Manhole Inspection Summary

Manhole # S17I__031MH

Insp Date: **2/19/08 9:50 AM**

Location Address: **2325 s warwick ave**

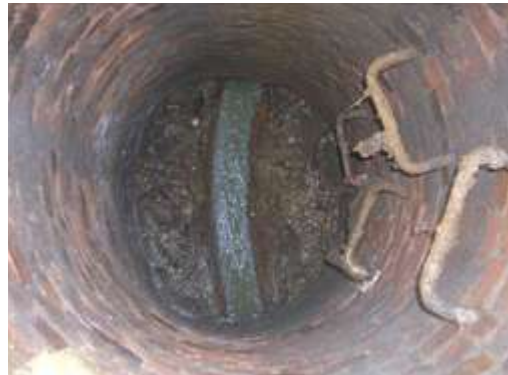
Top View

Condition: ☐ Sound ☐ Cracked ☐ Root Intrusion ☐ Deteriorated ☐ Leaks ☒ **Debris**

bench debris

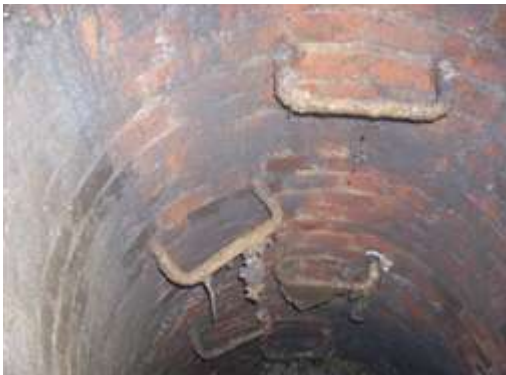
Defect 4

Surcharge ☒ **Evidence Of Surcharge** Depth: **8** (ft.) ☐ Active Surcharge Present

surcharge evidence on the steps

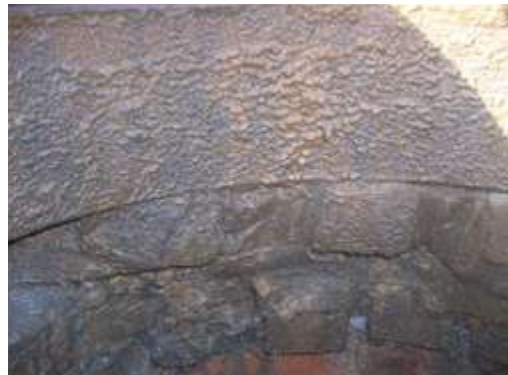
Defect 3

Frame Offset: **3** (in.) Condition: ☐ Sound ☐ Cracked ☒ **Leaks**

Condition: ☐ Sound ☐ Cracked ☐ Root Intrusion ☒ **Loose Brick** ☐ Deteriorated

frame leaks, loose chimney bricks

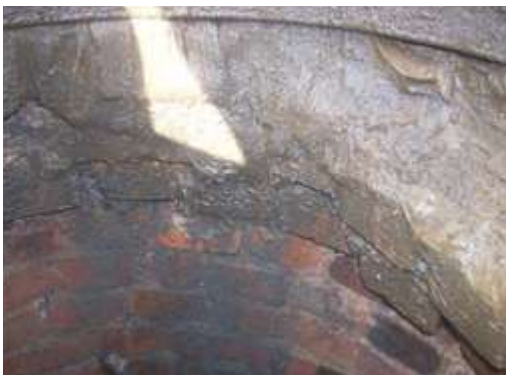
Defect 2

Infiltration: ☐ None ☒ **Joint** ☐ Cracks ☐ Mortar ☐ Roots ☐ Wall

infiltration evidence at the joint

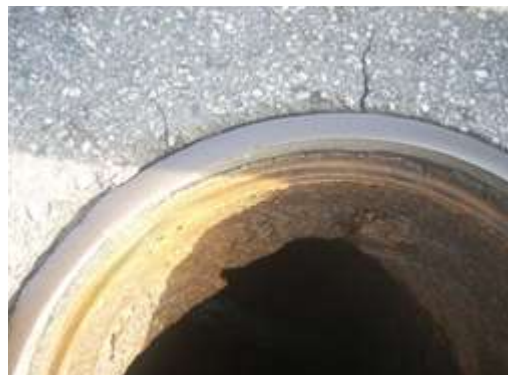
Defect 1

frame offset

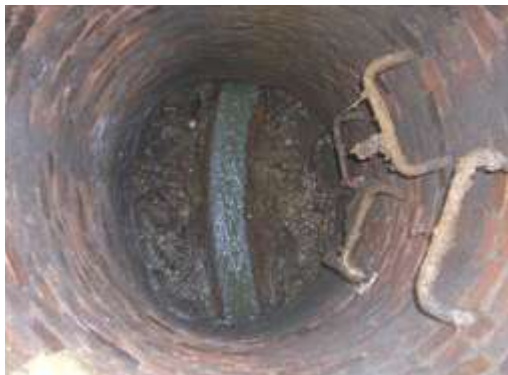
Defect 5

Steps Count: **6** Missing: **0** ☒ **Corroded**

corroded steps, bench debris

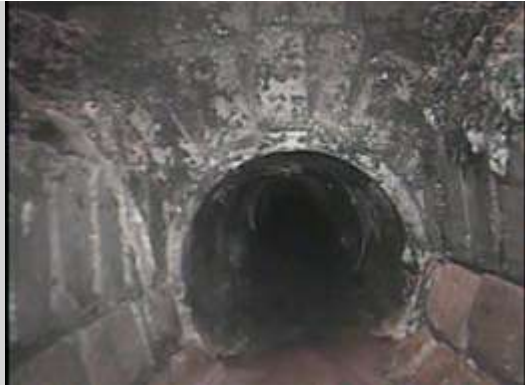
12 O'Clock Outflow

10 in. Circular Gravity Sewer
Pipe Out @ 12 O'Clock

Pipe Height: **10.8** (in.) Rod and Bar (Angled)
Pipe Material: **Clay** ☐ Pipe Lined
Invert Depth: **10.45** (ft.) Flow Characteristics: **Slow**
Deposits: ☒ None ☐ Mud ☐ Sludge ☐ Debris ☐ Grease
Silt Depth: **0** (in.) Deposits Extent:
Infiltration: **None** Pipe Seal Cond: **Sound**

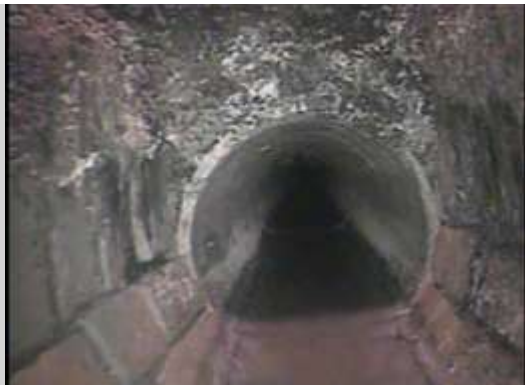
5 O'Clock Inflow

10 in. Circular Gravity Sewer
Pipe In @ 5 O'Clock

Pipe Height: **10.8** (in.) Rod and Bar (Angled)
Pipe Material: **Clay** ☐ Pipe Lined
Invert Depth: **10.34** (ft.) Flow Characteristics: **Slow**
Deposits: ☒ None ☐ Mud ☐ Sludge ☐ Debris ☐ Grease
Silt Depth: **0** (in.) Deposits Extent:
Infiltration: **None** Pipe Seal Cond: **Sound**
